SLOPE STABILITY AND GEOLOGY
OF THE BALDWIN HILLS,
LOS ANGELES COUNTY, CALIFORNIA

1982

CALIFORNIA DEPARTMENT OF CONSERVATION
DIVISION OF MINES AND GEOLOGY

SPECIAL REPORT 152

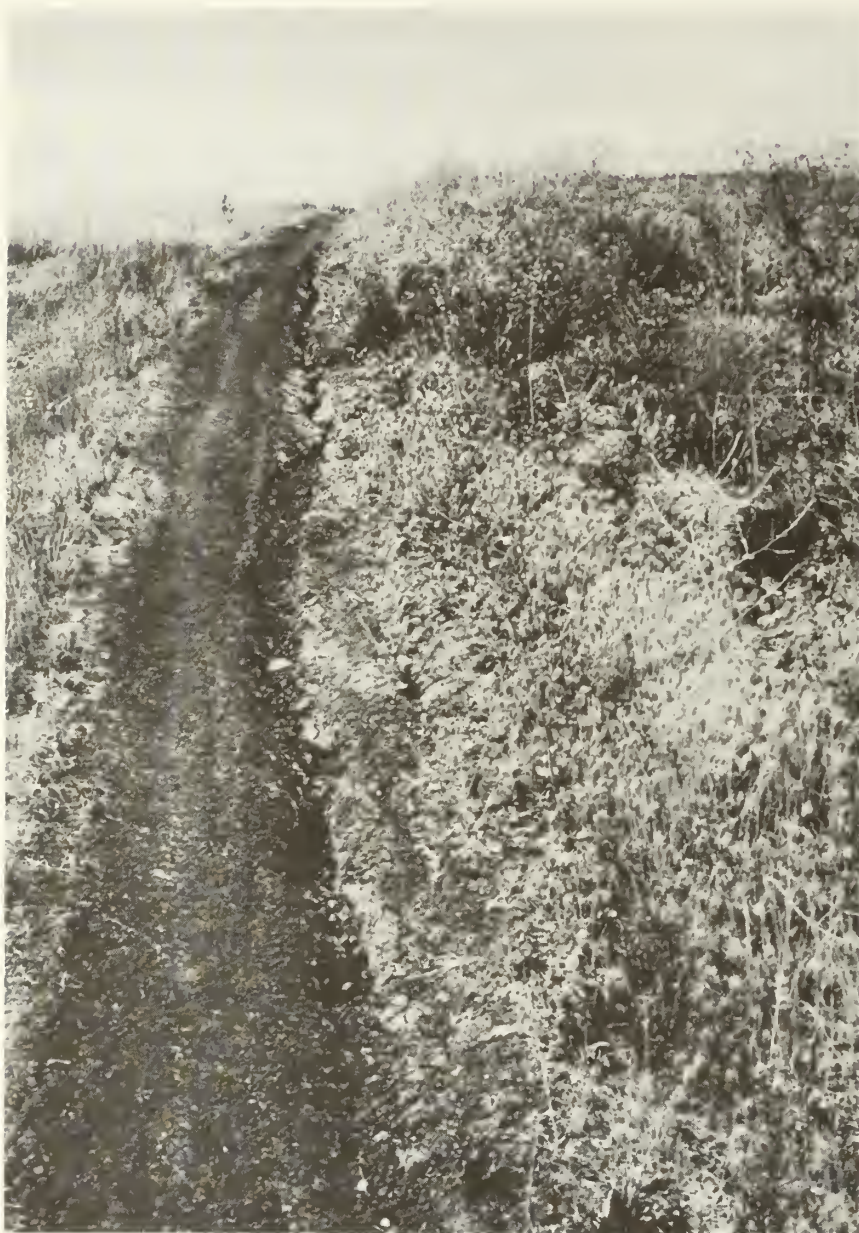
Photo 30. A dirt bike trail showing the first stage in the opening of the ground surface to erosion. The trail has "balded" away the vegetation, exposing the soil to incipient channeling during water runoff that was formerly spread out by the carpet of vegetation, but which now tends to follow the trail. (Locality 92, Sub-area 5, Plate 1.)

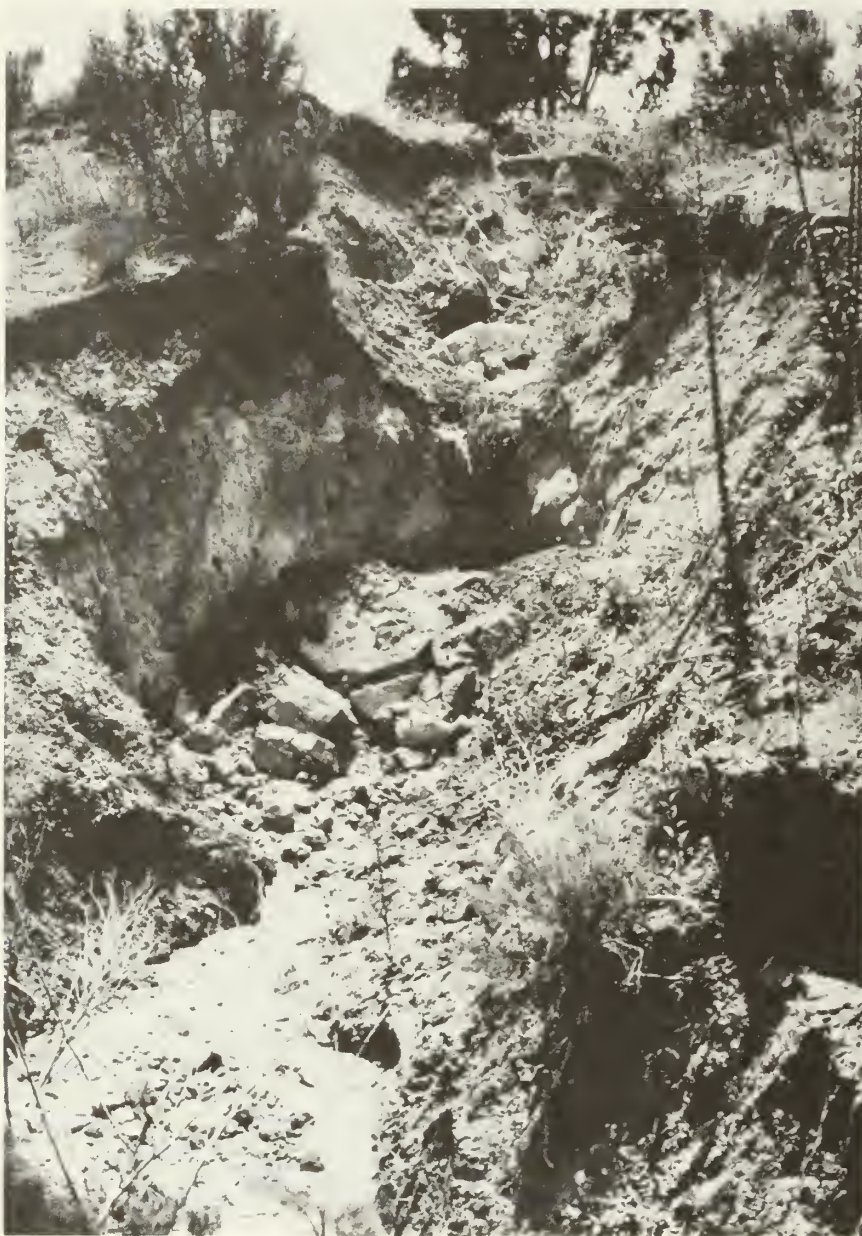
Photo 32. Inglewood oil field area. Gullying down slope from a paved area caused by water that drained without a prepared channel or conduit. Rock unit eroded is the Baldwin Hills sandy gravel. Note the thin soil mantle. Compared with Photos 30 and 31, note the more irregular, blocky surface of the exposed rock in this scene. Although soft and easily eroded, there is enough clay in this rock to make it much firmer than the Culver sand (Photo 5). Note also the generally blocky character of the dislodged material.

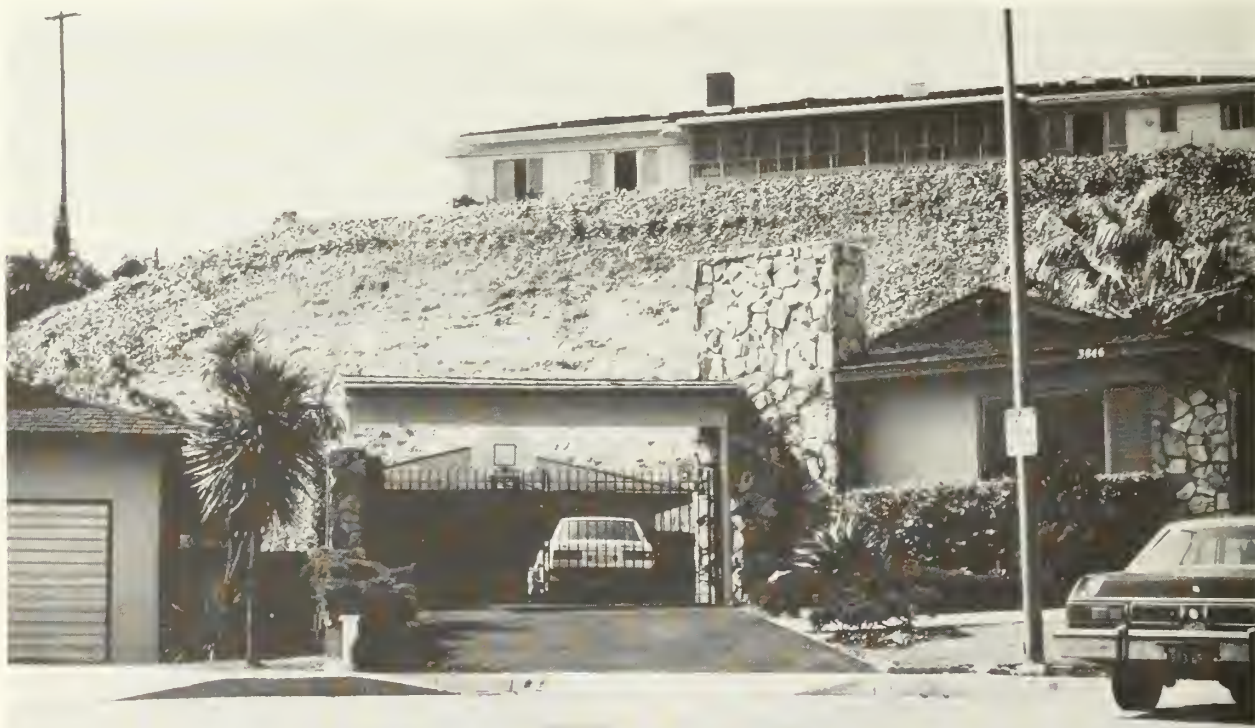
Photo 34. View south in cul-de-sac of Crestview Road in Culver City, in northwestern Baldwin Hills. View shows slope that failed in 1978 as restored with fill and soil cement before the 1980 rains. The newly repaired slope suffered no damage in 1980 even though it was bare of vegetation. House shown on top is on Howardview Court. (Locality 6, Sub-area 1, Plate 1 and Table 3a.)

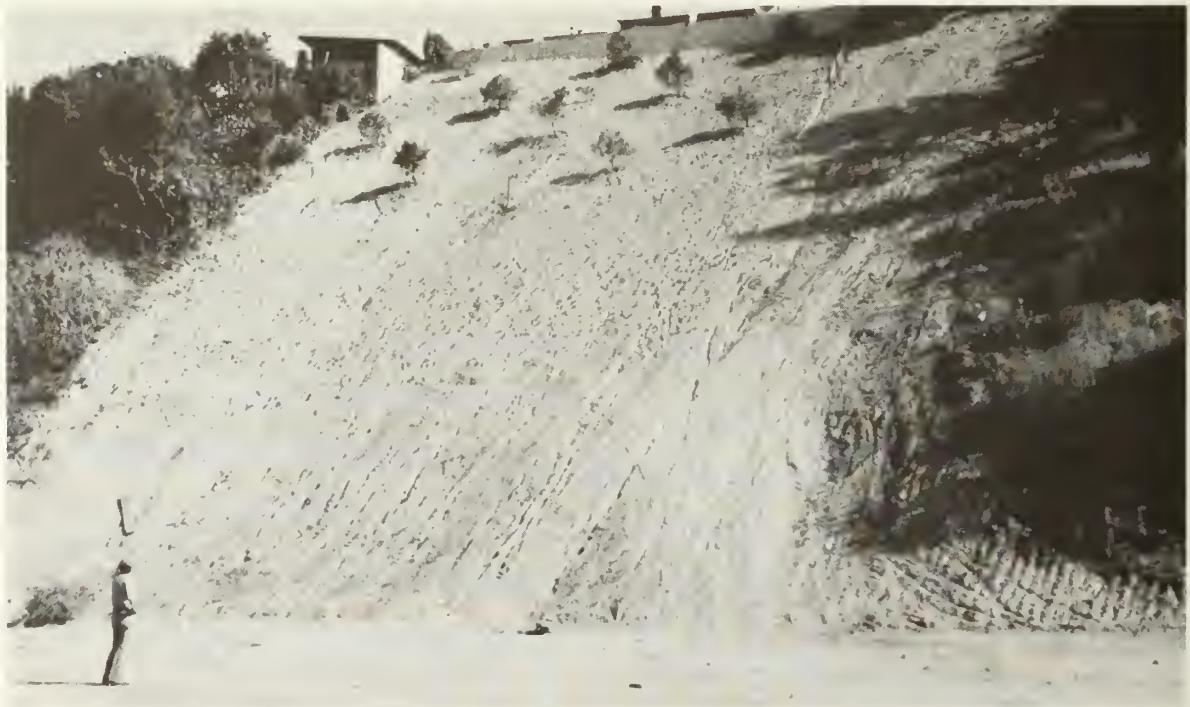
Photo 35. View east in February 1981 shows steep slope on east side of Cloverdale Avenue that was reggraded with a retaining wall constructed at the top of the slope after the 1980 rains. The slope was seriously damaged by rains in 1978 and then expediently repaired with board and pipe revetment structures that were undermined by runoff during the 1980 rains. Note that erosion accompanying the 1981 rains has caused some rilling damage to slope. (Slope segment 2-0.)

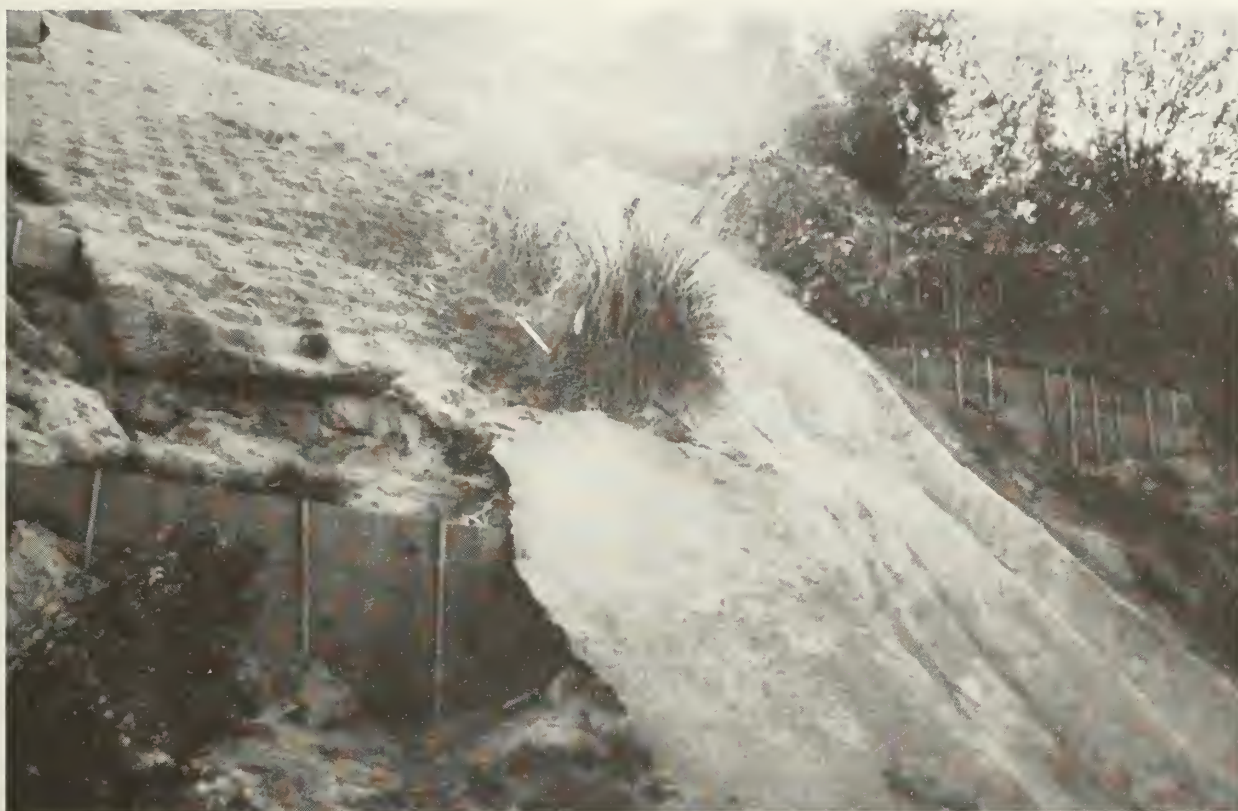
Photo 36. View south on Don Milagro Drive shows the base of a steep slope with a partial cover of gunite as well as board and pipe revetment structures. (Slope segment 2P.)
